328-330
CAMB. ST.

Burlington's Reed Ham Works Barn: An Evaluation

328-330 Cambridge Street
Burlington, MA
by John Goff

Prepared for the new Owners and the
Burlington Historical Commission for their meeting of
June 19, 2019

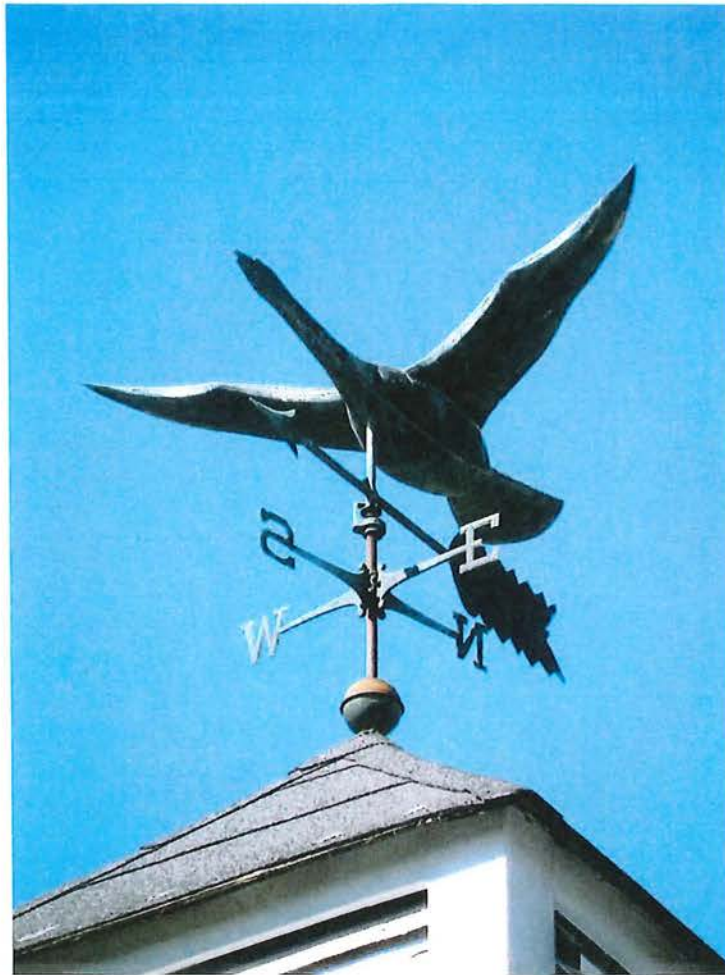
Photograph # EX-21

Subject: View looking south and west at the **METAL FLYING BIRD WEATHERVANE** atop the FRONT SECTION of the LONG BARN STRUCTURE(S) also called Barn #3 on the marked-up site plan.

Note: We are not weathervane specialists. However, this (ca. 1960?) weathervane appears to have been well designed with a large Canada Goose-like bird fabricated from custom sheet copper, mounted atop a (rusty steel?) vertical support rod to which the four cardinal direction (NESW) arms were mounted. The folk art-referencing FLETCHED ARROW (suggesting Colonial times and Indians with bows and arrows) adds to the interest.

We are not sure if this weathervane was additionally designed and grounded to serve as a lightning rod (and thus to protect the barns from accidental fire) but in any case, this architectural element is fine and, despite its lack of age, would be rated a SHOULD BE SAVED feature.

Feature	MUST BE SAVED	SHOULD BE SAVED	NEED NOT BE SAVED	Remarks
Barn 3A (west end of WEST ELLS—about 22 feet square)		X		Explore possibility of working with other parties to relocate early barn to another location—for restoration on another site.
Long Barn—Rear Section			X	May be demolished
Long Barn –Middle Section			X	May be demolished
Long Barn—Front Section			X	May be demolished
Historic stones from stone wall(s) in front of the complex	X			Explore possibility of working with other parties to relocate historic stones and/or stone walls to another location—for public access, education & preservation.
Ca. 1960s? sheet metal flying bird weathervane and associated hardware		X		Re-use or sell weathervane.

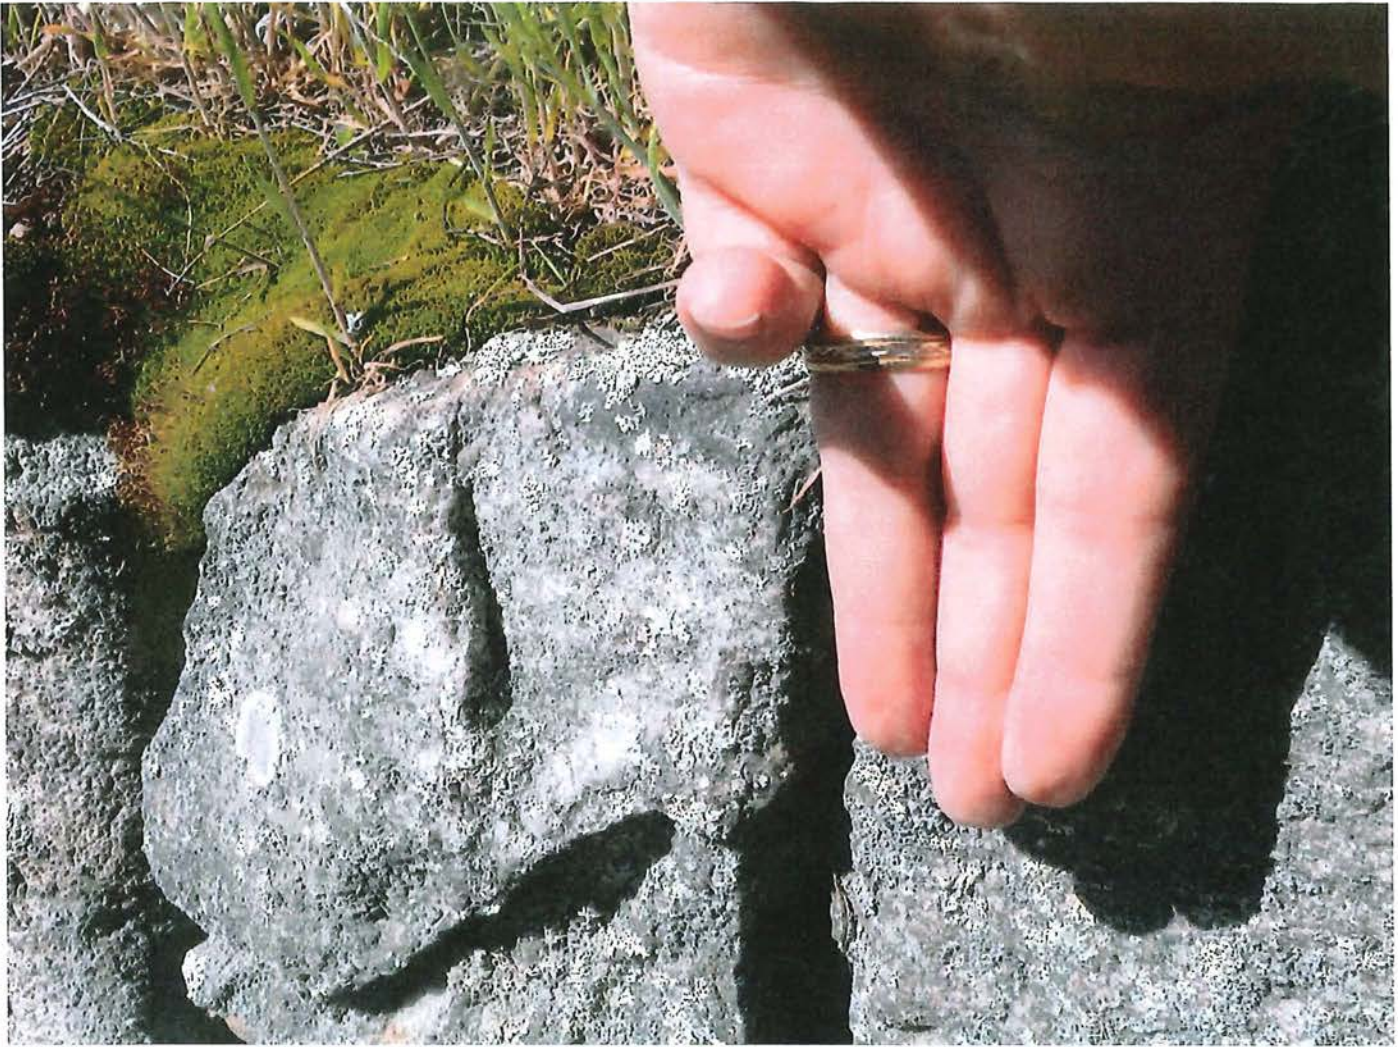
Photograph # EX-26
Reed Ham Works Barn Site, Burlington, MA
Date: May 9, 2019 **Photographer:** John Goff

Subject: Detail view of a possible colonial keystone-shaped quarry mark in the STONE WALL in front of the barn complex.

Note: While studying some of New England's earliest and last surviving water-powered tide-mill complexes in Quincy, MA between 1991 and 2000 [including the Souther Tide Mill on the Town River, and the Edmund Quincy Tide Mill on the nearby Black's Creek] we learned that some of the earliest stone walls erected in America were built using curious keystone-shaped indentations in some of the stones. It seems that before the "cylindrical hole" drilling and splitting methods were developed [ca. 1820?], an older and colonial way of stone extraction existed—that reportedly used the shaping of keystone shape holes, the insertion of wood wedges, and the expansion of the wood using water being added—which made the wedges swell. Our guess is that the stone(s) surviving with KEYSTONE-SHAPED INDENTS on the Burlington property were recycled from lost colonial walls or structures. They are rare, and warrant both further study—and long term protection.
